{NASA-CR-153935} RESULTS OF  
GRAPHITE-POLYIMIDE ISOGRID PANEL TESTING  
Interim Report {Old Dominion Univ. Research  
Foundation) 57 p HC A04/MF A01 CSCL 11D

## RESULTS OF GRAPHITE-POLYIMIDE ISOGRID PANEL TESTING

Interim Report

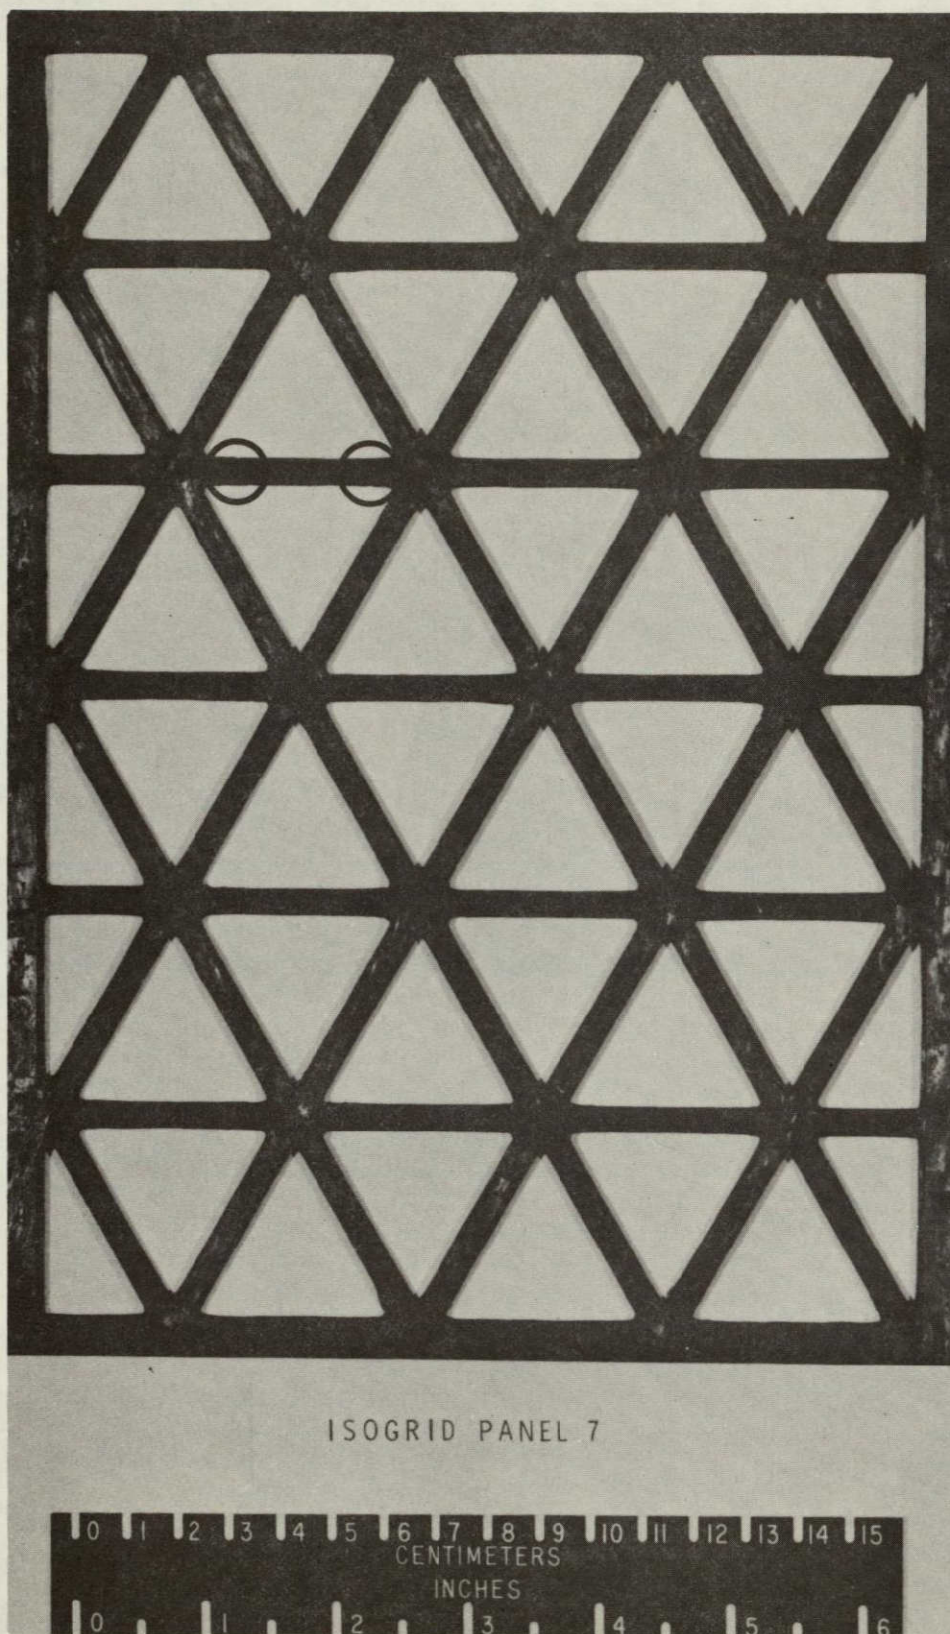
Figures 1 and 2 show open isogrid panels 7 and 8, respectively. The two open isogrid panels are identical except for minor imperfections. These are circled in the figures. Initially, McDonnell-Douglas had problems with resin starving

during the fabrication process and six panels were fabricated before a satisfactory panel resulted. However, no panel was completely free of resin starving but on the test panels there were only a few isolated areas.

Figure 1. Isogrid panel 7.

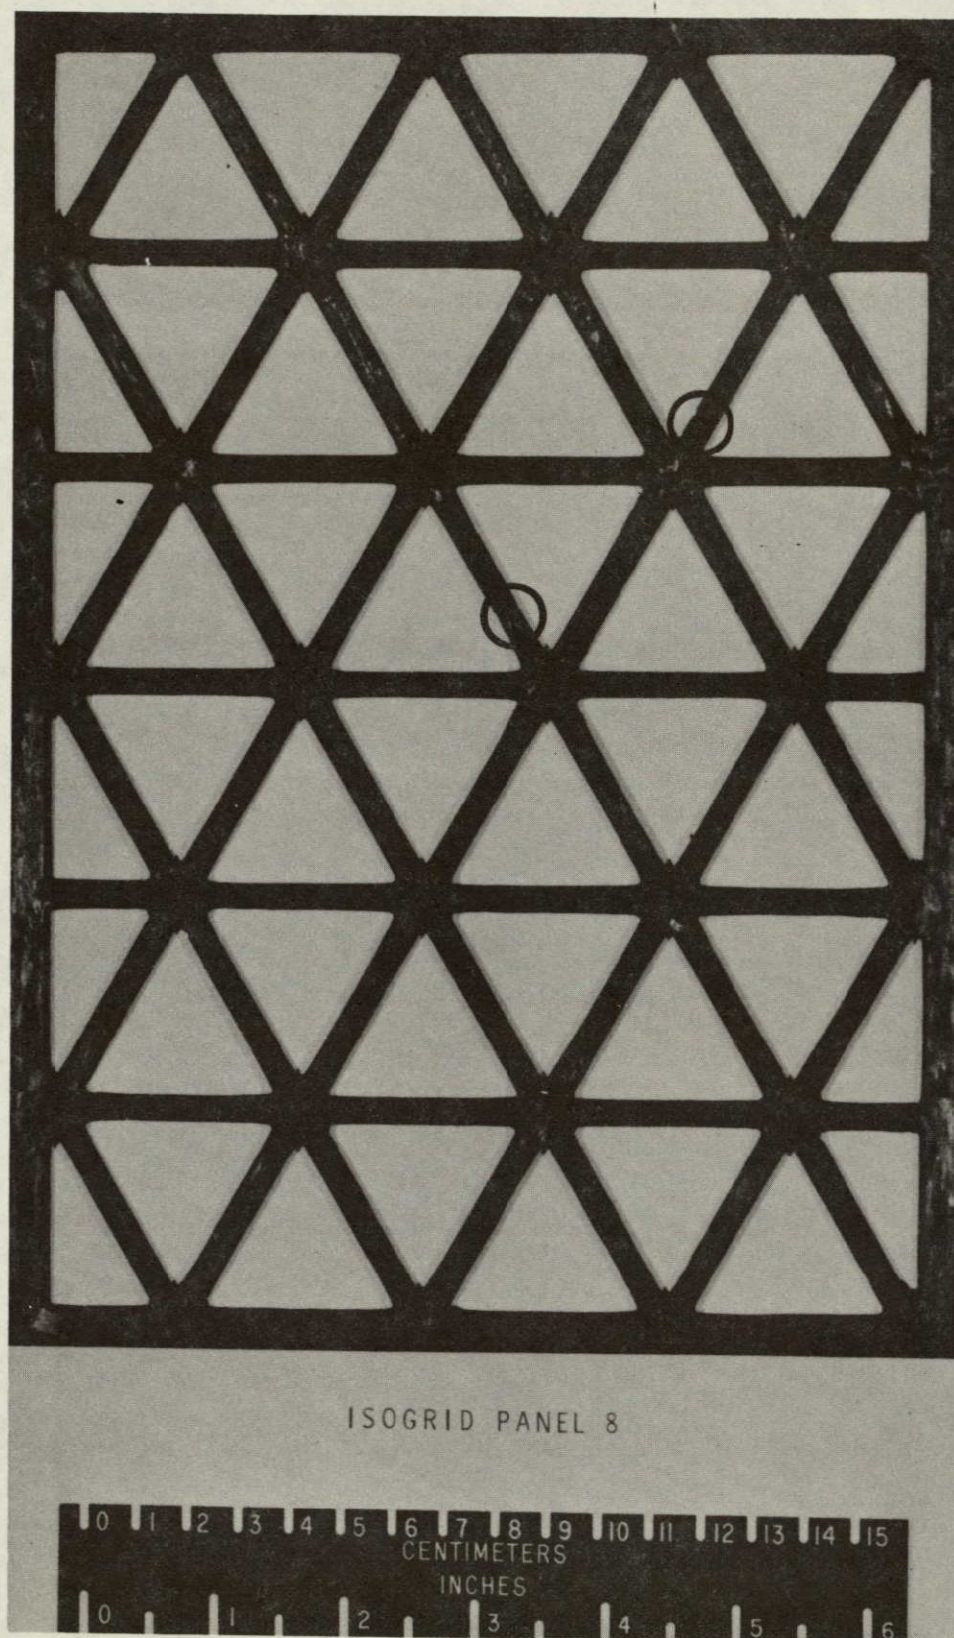
Examination of the panel indicated the local failure near node 72 occurred in one of the legs that had a resin-starved imperfection. In figure 2 this is the imperfection in the upper right.

Figure 2. Isogrid panel 8.

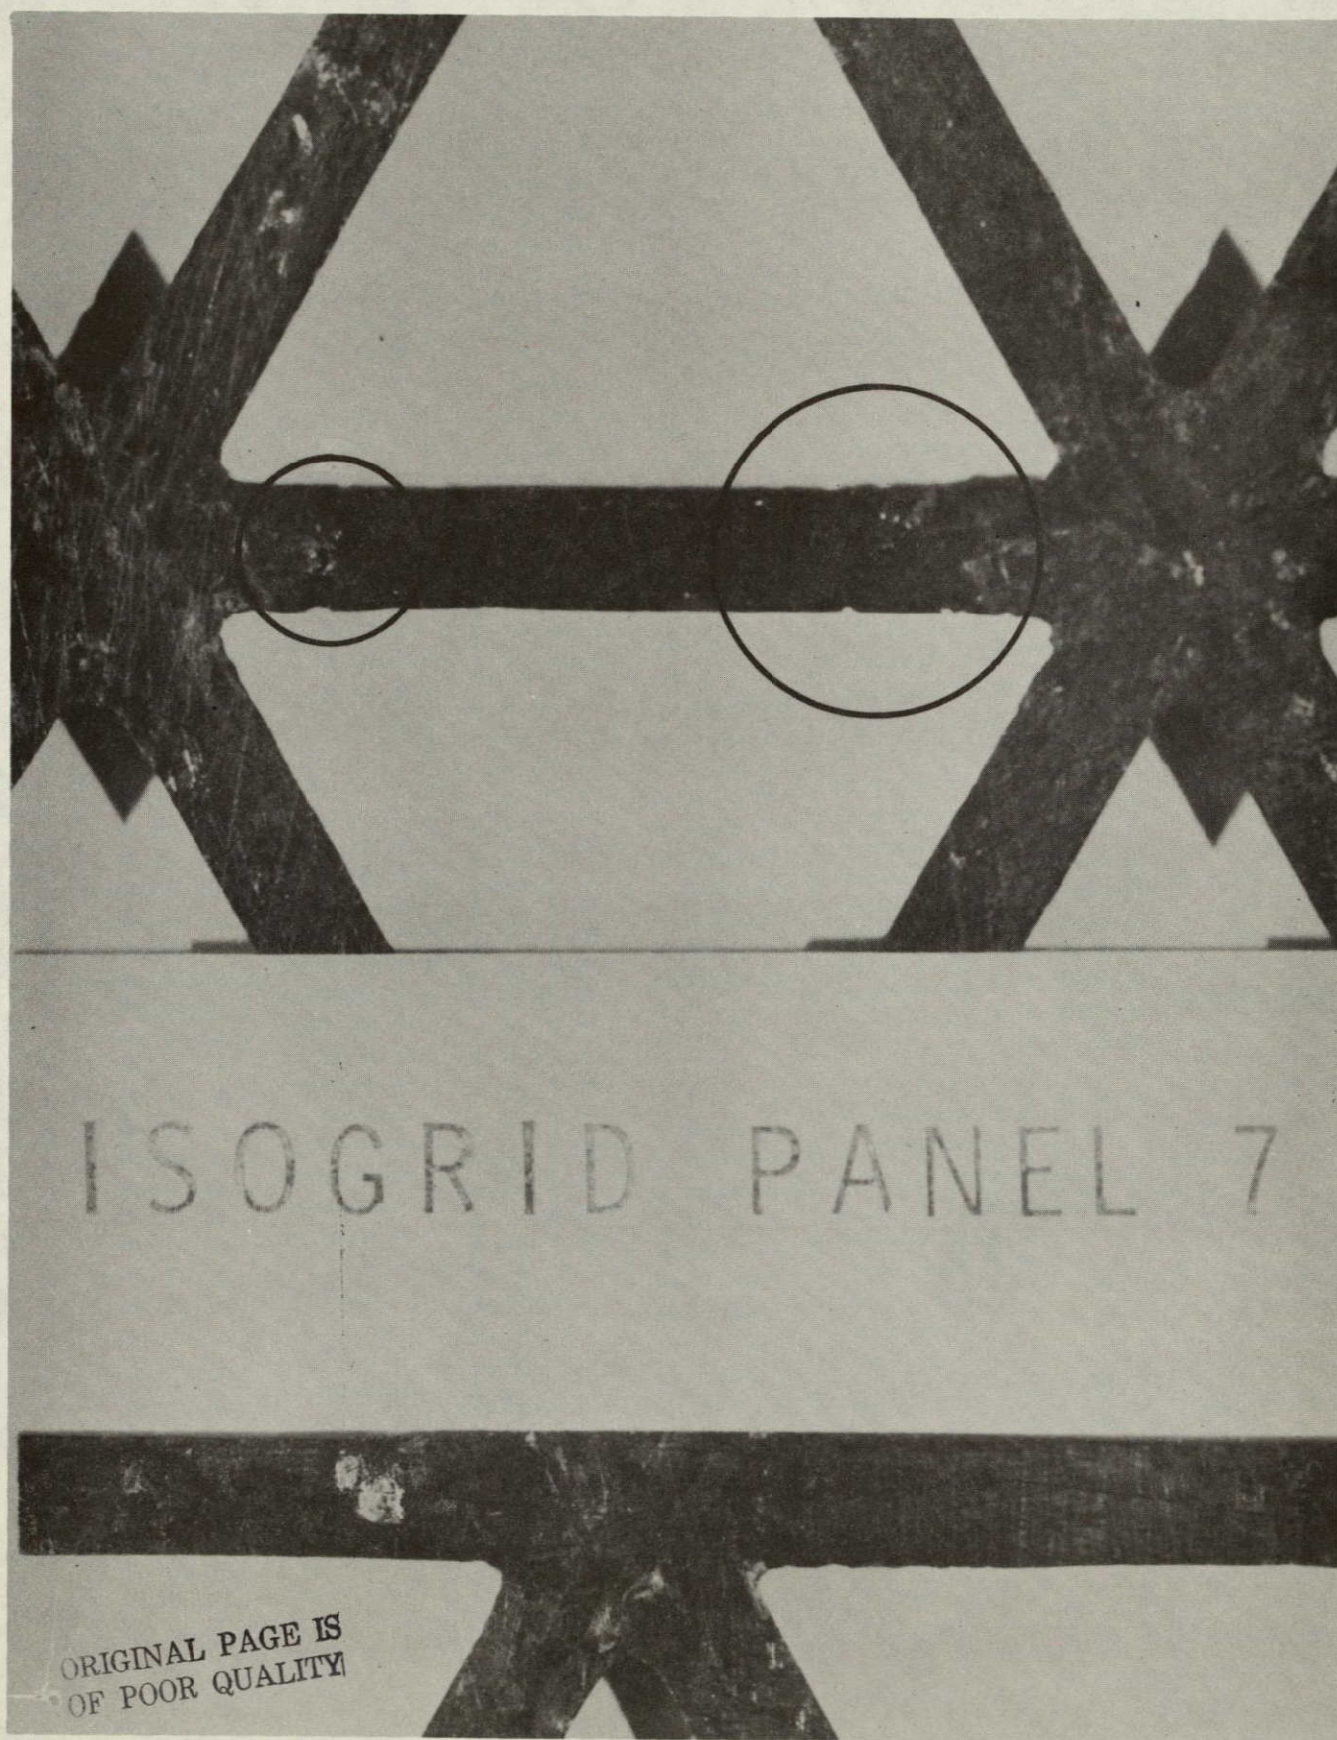
The imperfections in panel 7 did not penetrate the legs in the grid work as deeply as the imperfections in panel 8 and were most obvious from the back. Figure 3 shows a detail of the back of panel 7 in the area of the imperfections. Figures 4 and 5 show details of the front and back sides, respectively, of panel 8 in the area of the imperfections.

Figure 3. Imperfections in panel 7, back side.

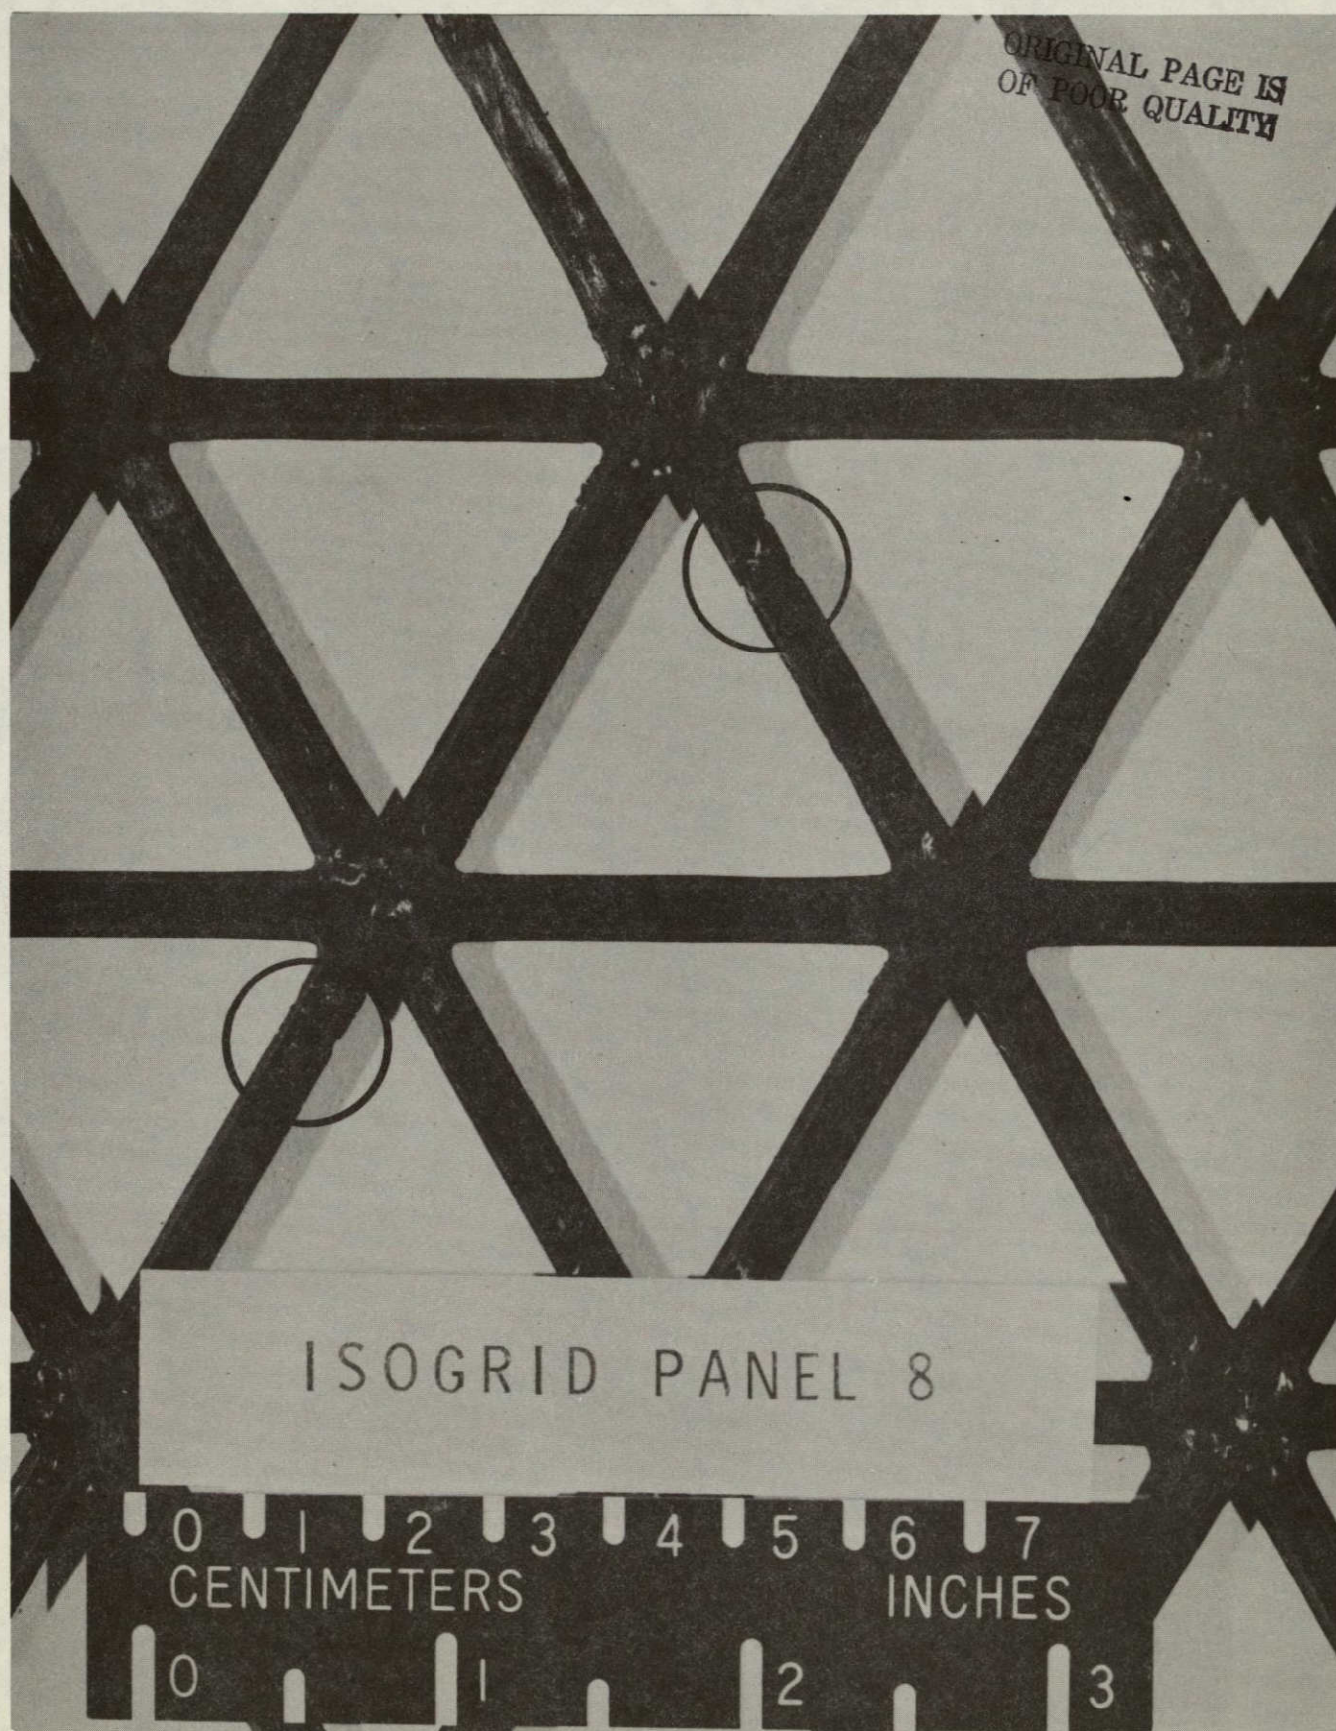
Figure 4. Imperfection in panel 8, front side.

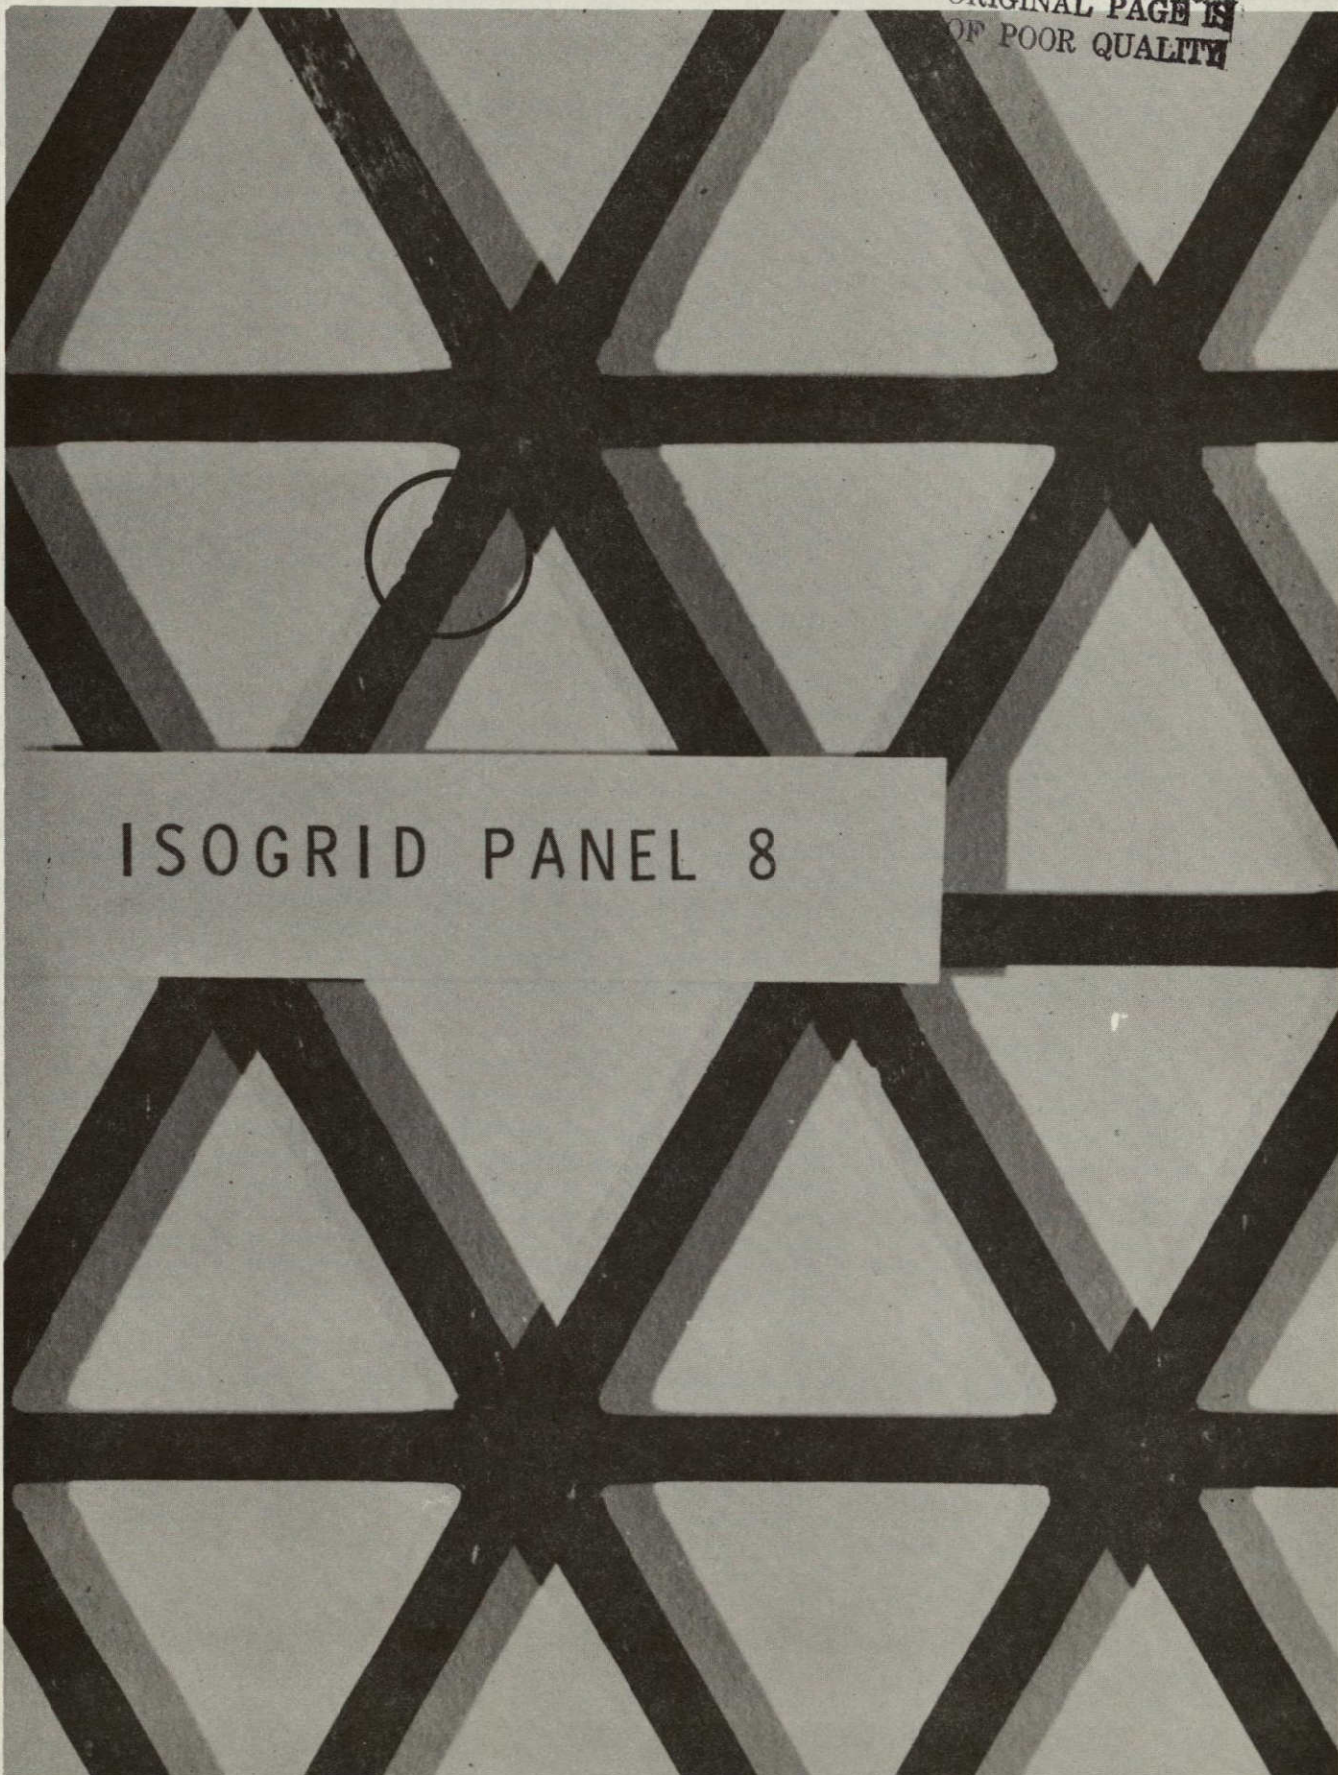
ISOGRID PANEL 8

Figure 5. Imperfection in panel 8, back side.

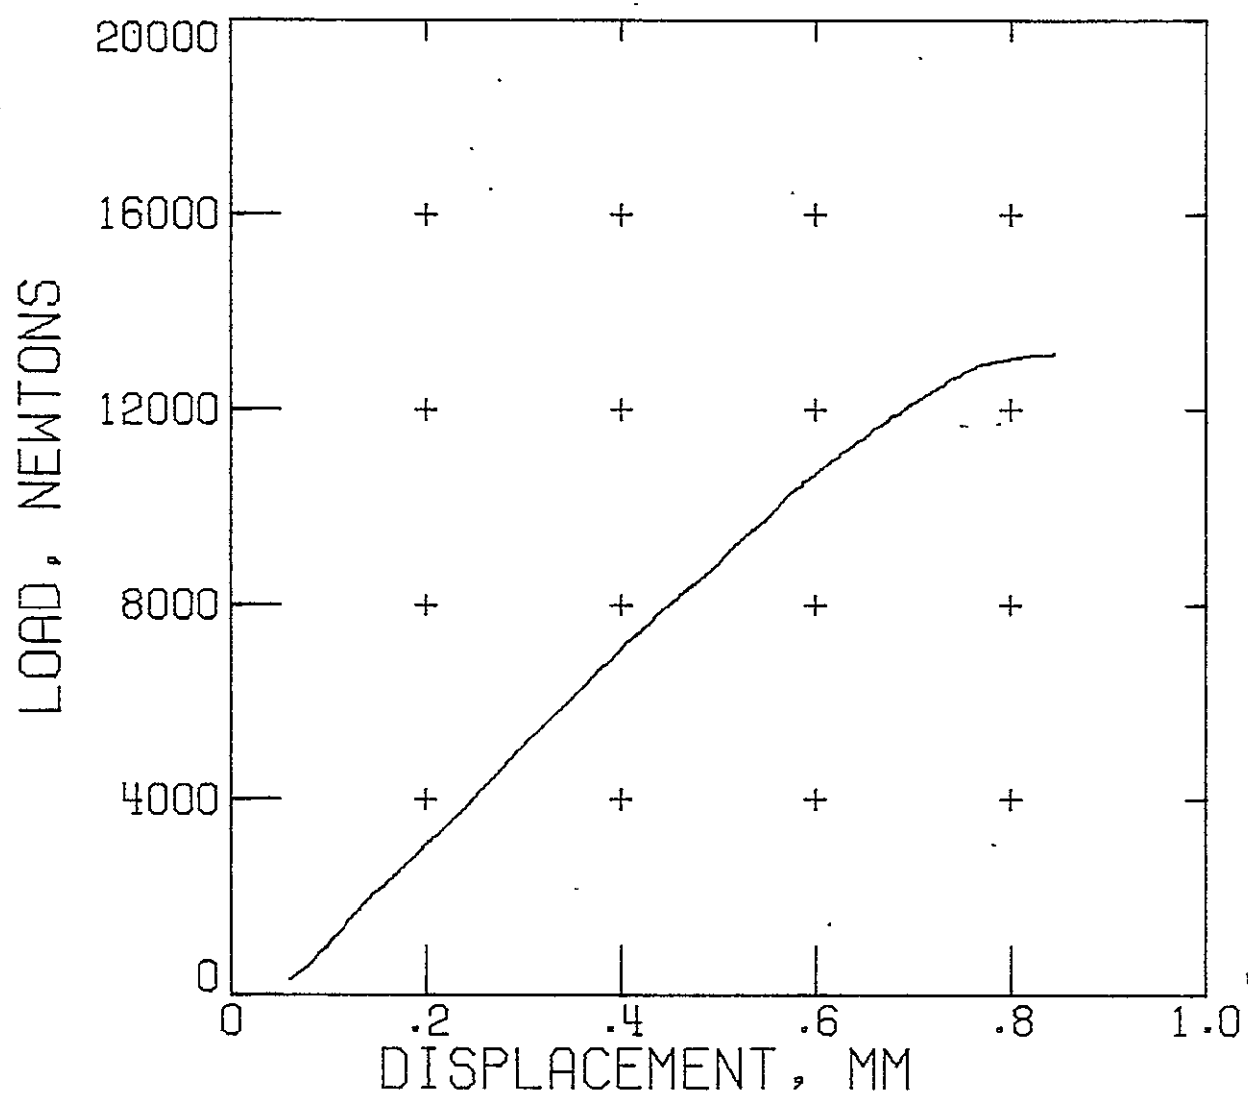
for in-plane shortening. The failure above the knife edge was unexpected, but as soon as the plastic hinge formed and allowed rotation, the only place the longitudinal edge pieces could develop curvature was in the region not supported by the knife edge. The leveling off in load at the end of the in-plane load-deflection history, figure 12, is attributable to this bending failure.

Figure 12. In-plane load-deflection behavior, panel 7.

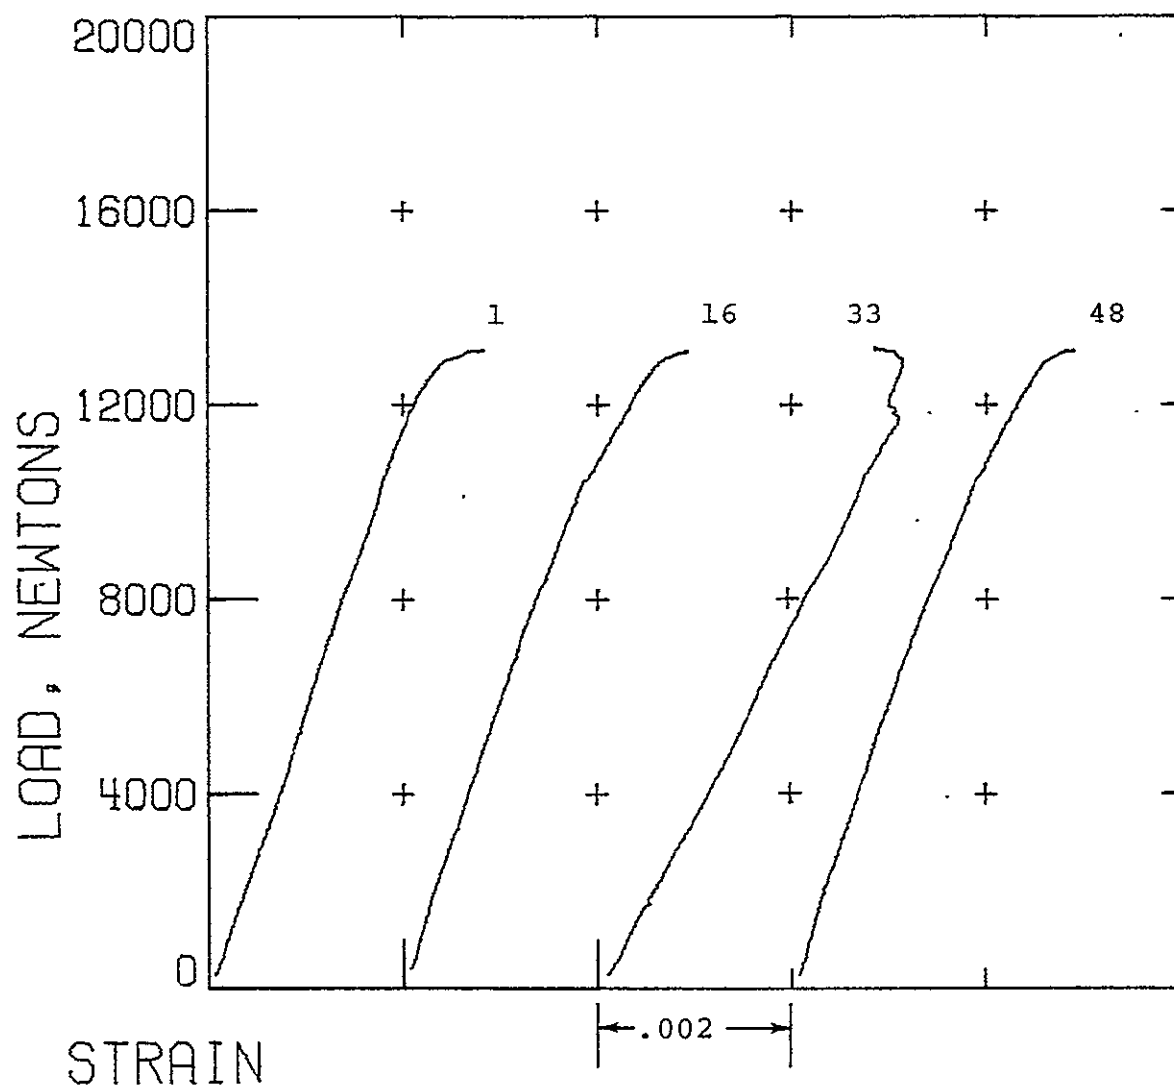
Figure 19 indicates the strain in gages 1, 16, 33, and 48. It is evident that each leg carried approximately the same load and the load was uniform along its length.

Figure 19. Strain versus force for gages 1, 16, 33, and 48 on panel 7.

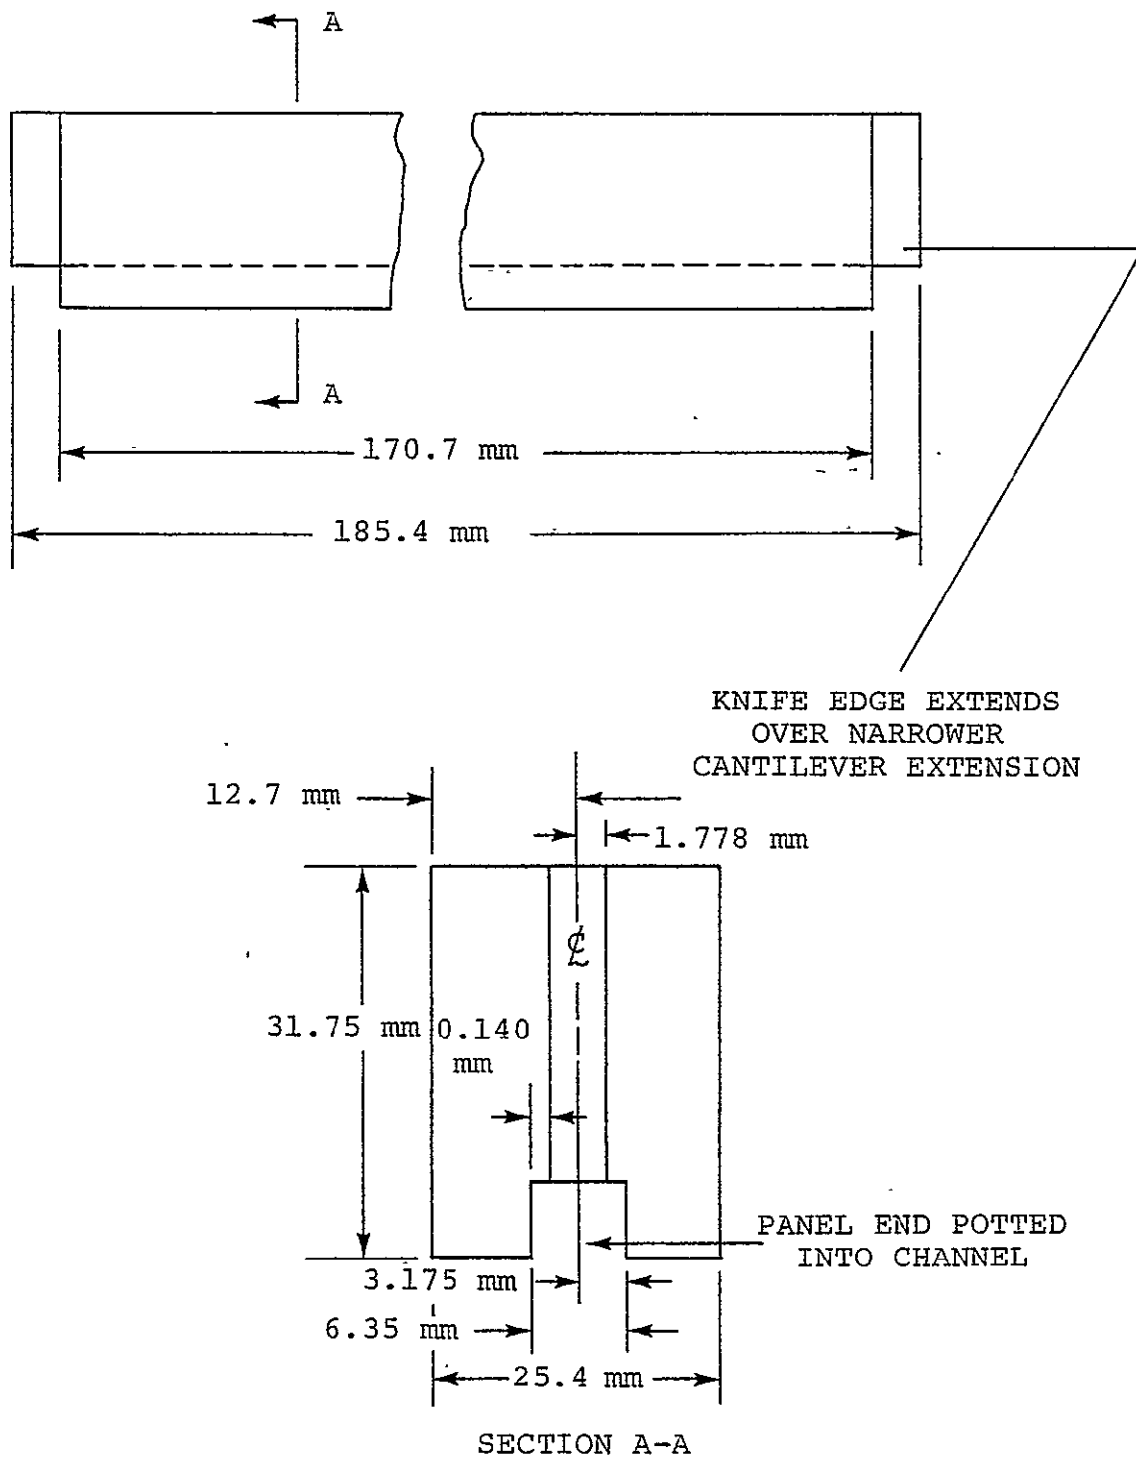
In order to avoid problems with the plastic hinge rotation and localized bending at the ends of the knife edges, the test fixtures were modified for the second open isogrid panel test. The simply supported end concept was replaced by fixed-end pieces. Longer knife edges, 262 mm in length, were fabricated and the end pieces designed so the knife edges could extend beyond the upper and lower ends of the panel but still allowing plane shortening of the panel. The modified end fittings are shown in figure 20.

Figure 20. Modified end fittings for panel 8.

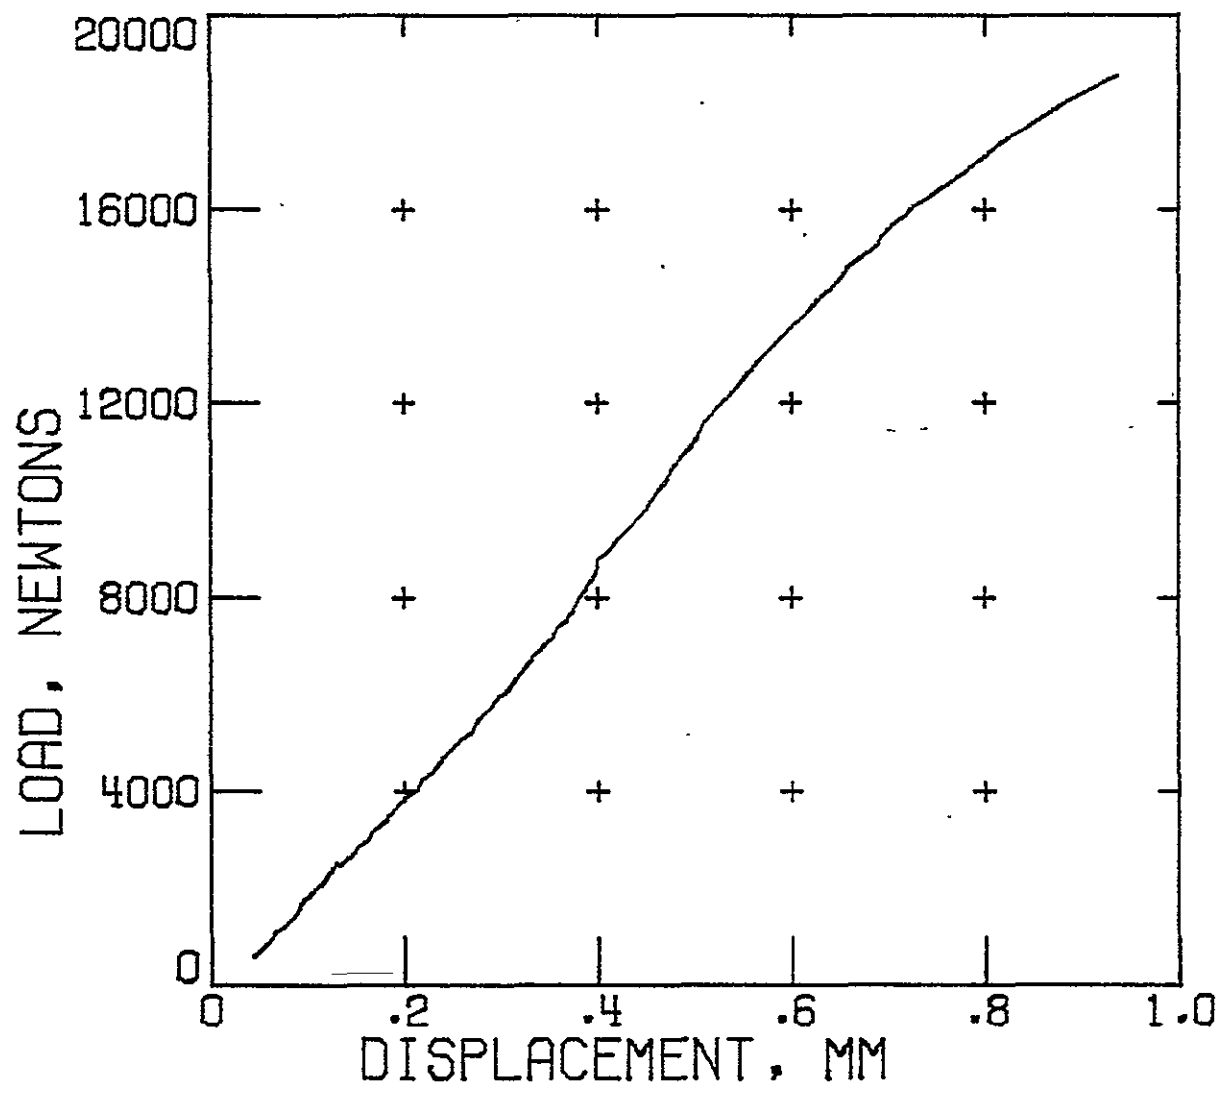
Panel number 8 supported a considerably higher load than panel 7 but sustained a serious local out-of-plane buckling failure near node 72. Figure 23 shows the in-plane load-deflection characteristics and there is no evidence of this local failure, which occurred around 16500 N. However, the failure propagated rapidly to the surrounding nodes and rather than completely collapse the specimen, the test was terminated so the initial failure could be examined.

Figure 23. In-plane load-deflection behavior of panel 8.

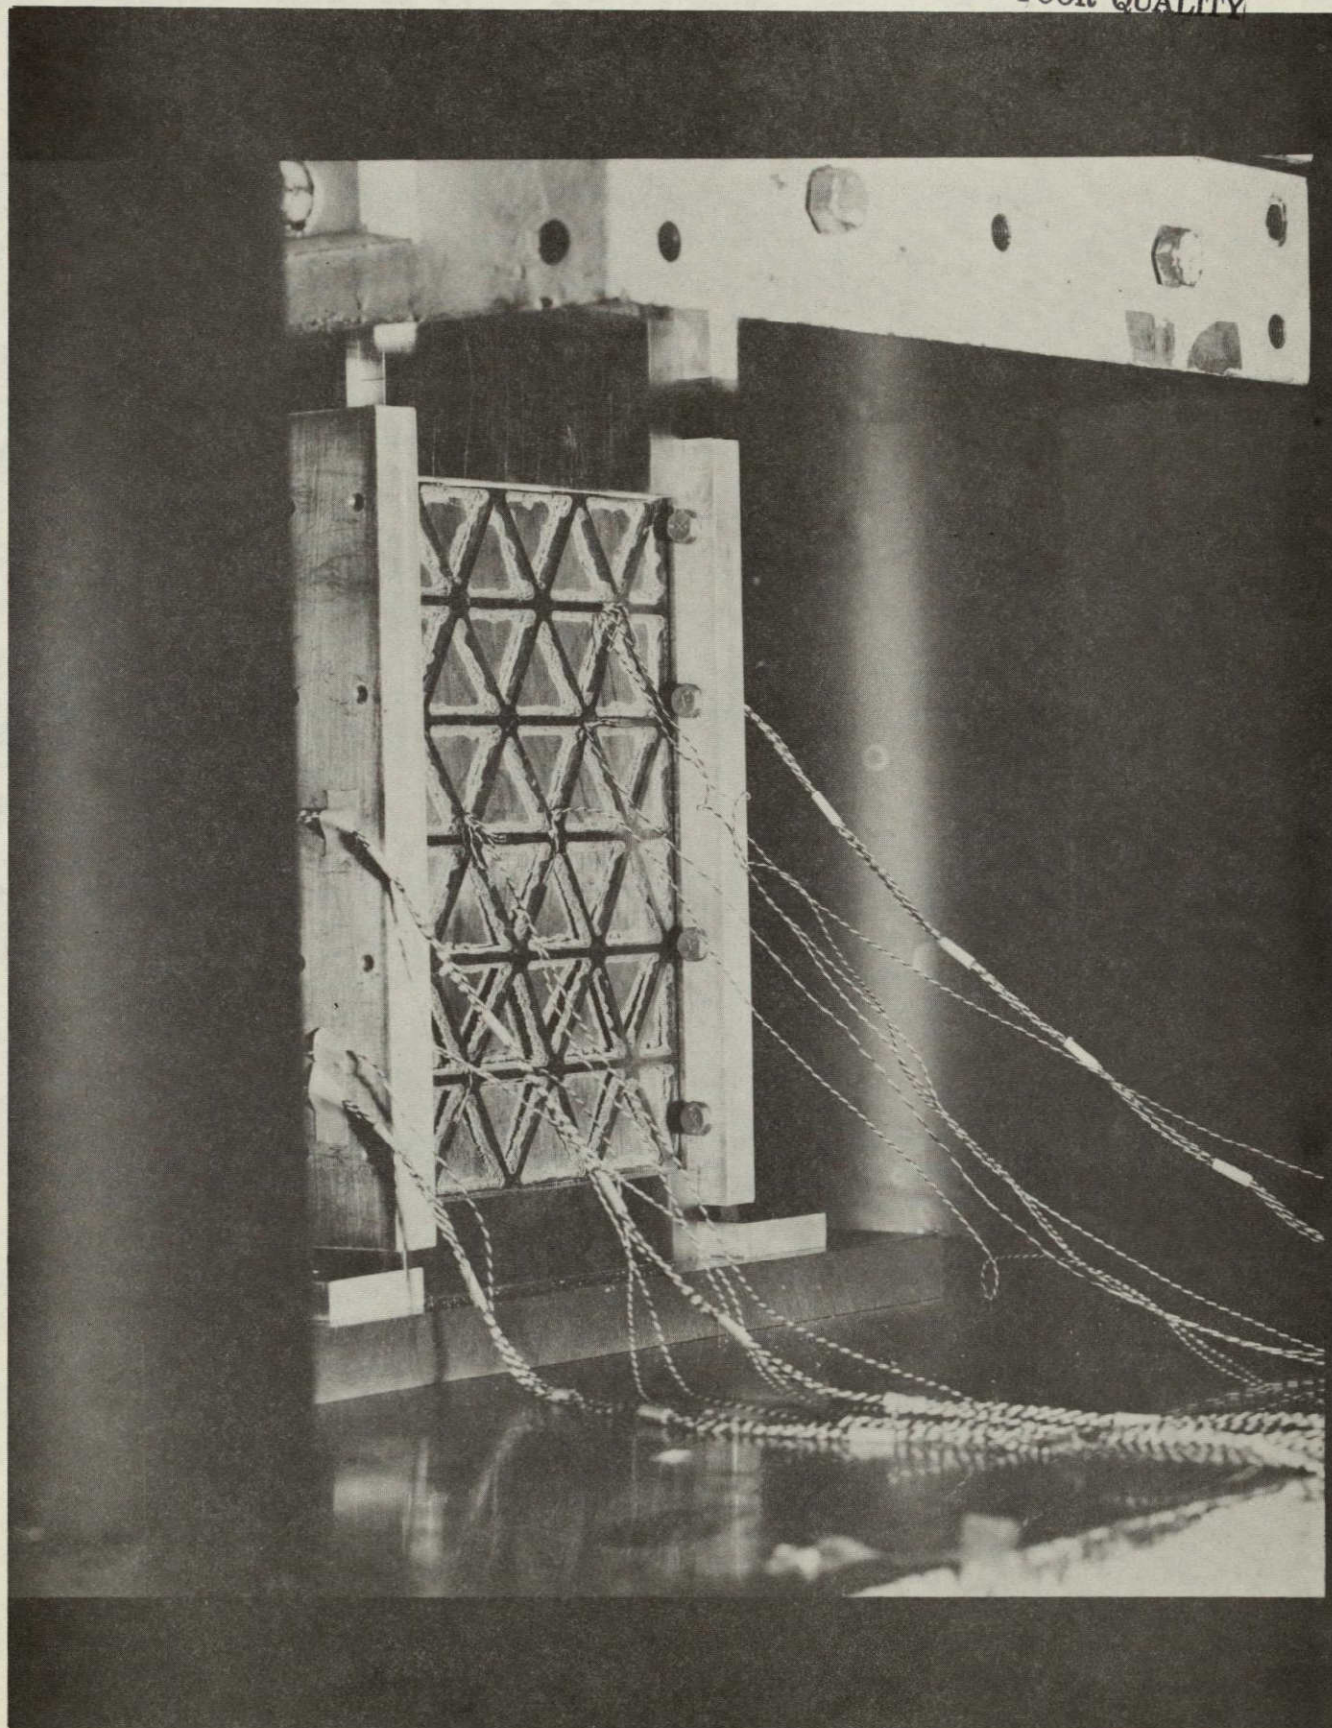
Basically the panel failed at a load of about 40050 N, due to separation of the skin from the isogrid backing over the lower 1/2 of the panel. This can be seen clearly in figure 31. In the failed configuration, the gridwork was bowed substantially backward while the skin was bowed forward slightly. The debonding appeared to start in the lower left hand corner at the panel (when viewed from the front).

Figure 31. Separation of skin and framework on skin-stiffened panel.

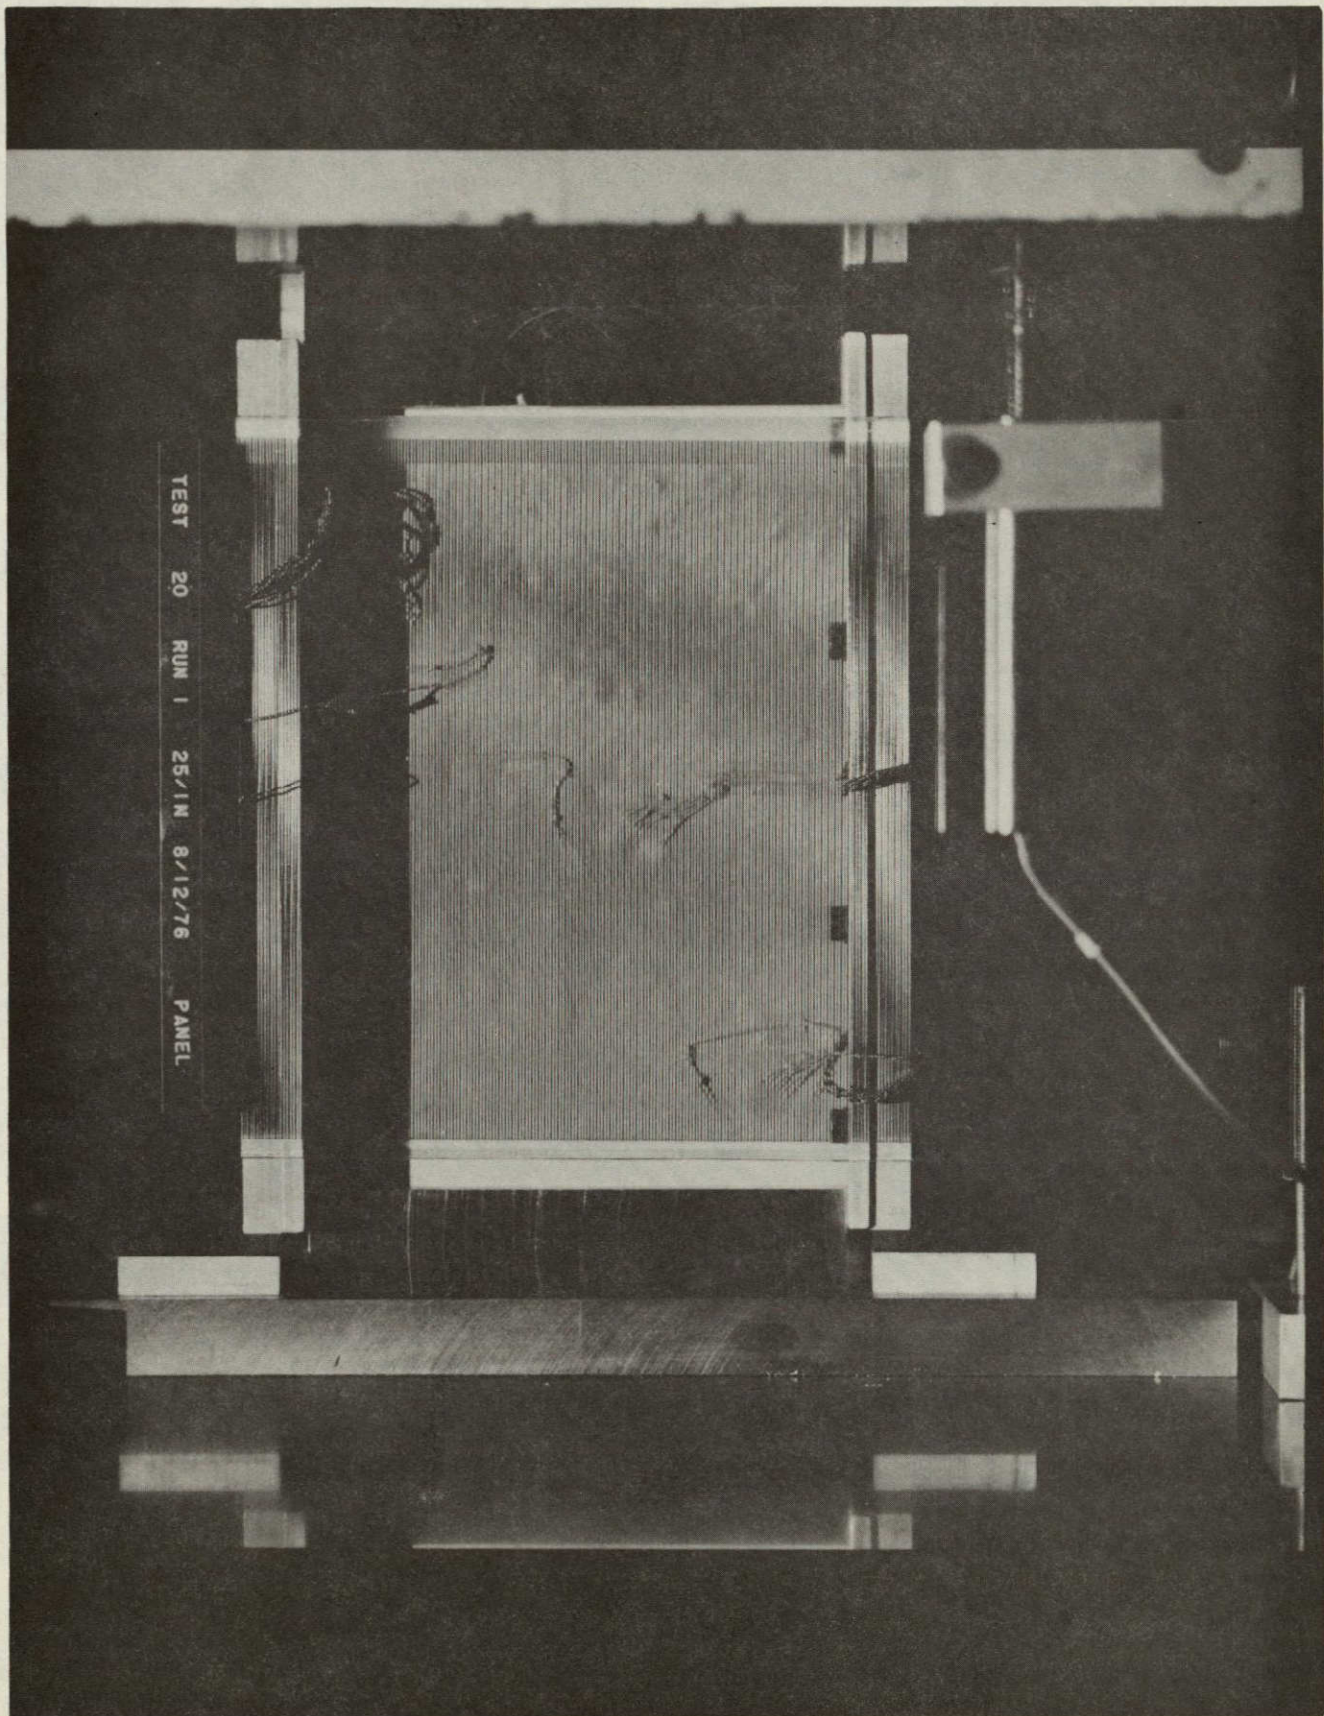
Figure 32. Moiré fringe pattern on panel 9 at no-load condition.
